SUBJECT Port Facilities, Activities, and Ship Sightings at Novorossiysk

SUBJECT: The Port of NOVOROSSISK

SUBJECT: Port of Novorossiysk

SUBJECT: Port of NOVOROSISK

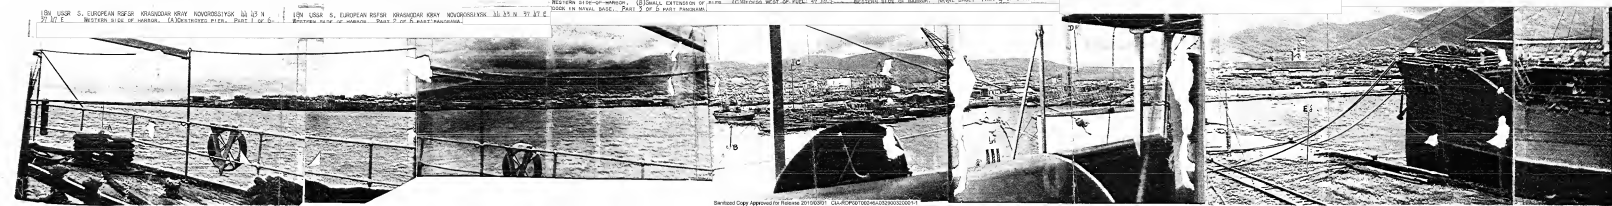
18M USSR S. EUROPEAN RSFSR KRASNODAR KRAY NOVOROSIYSK 44 43 N
37 47 E WESTERN SIDE OF MOUNT. (A) OCHINIKO PLE. PART 1 OF

10N USSR S. EUROPEAN REFOR KRAKOVODAR KRAK, NOVOROSSISK 33 33 N 37 37 E 10N USSR S. EUROPEAN REFOR KRAKOVODAR KRAK, NOVOROSSISK 44 43 N
REPERION SIDE OF MAP. (B) SMALL EXTENSION OF REPERION WEST ON FOOT 37 30 E. REPERION SIDE OF MAP. NAVAL BASE. PART 9 OF 6 PART
LOOK IN NAVAL BASE. PART 9 OF 6 PART PANGLOSS.
